Powersave Test Cases

Goal: Test and verify powersave mode on a station using various methods.

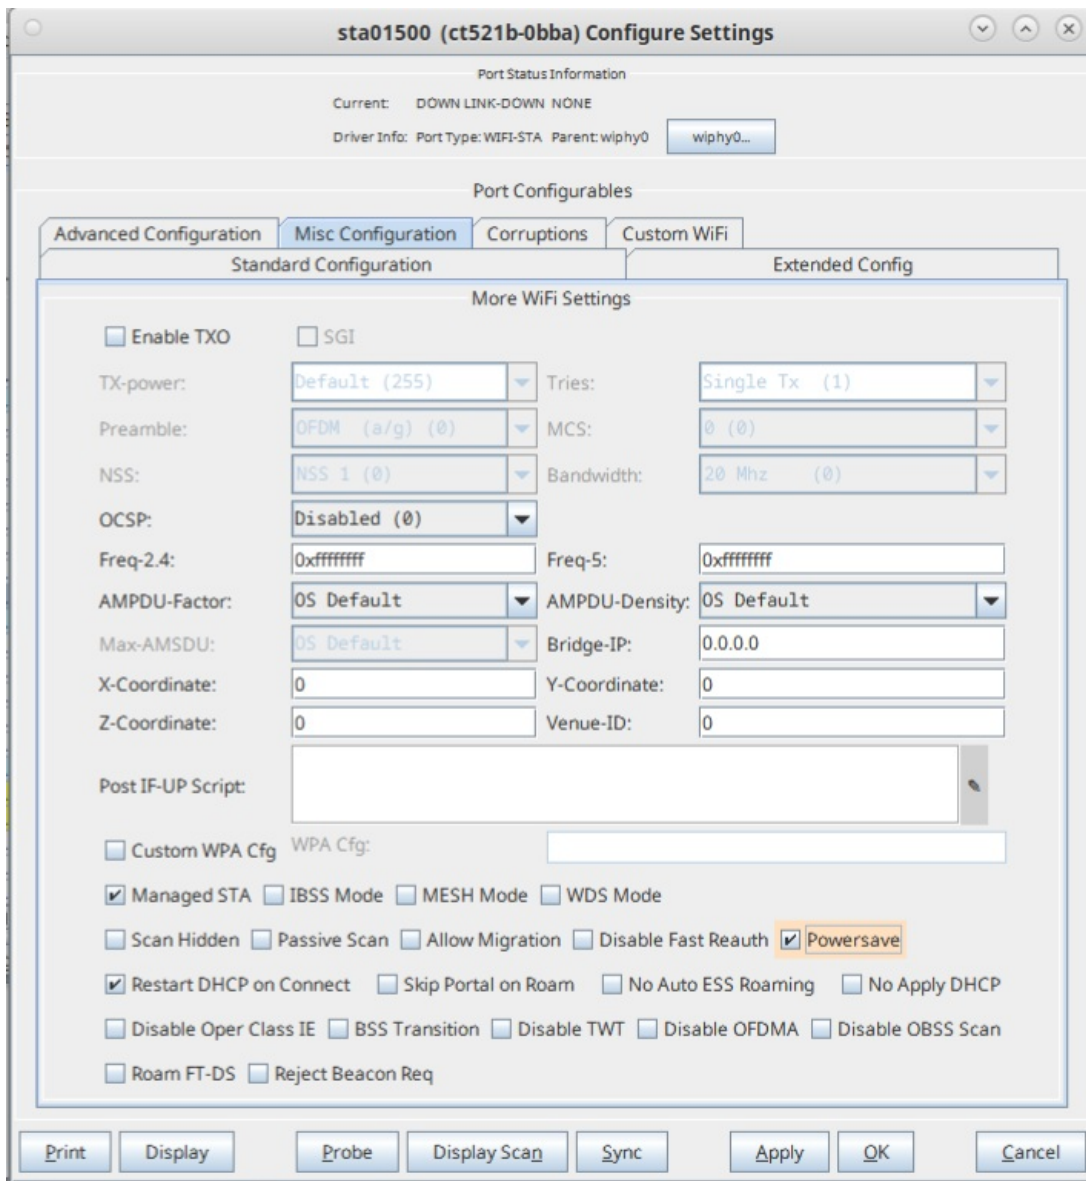
- Set up download unicast TCP traffic between upstream port and station. Set the Min Speed as 9 Kbps, Max Speed 128 Kbps, and 1400 as the Pkt Size.
- Double-click on the created station in the Port Mgr tab. Enable Powersave on LANforge station (in the Misc Configuration tab)

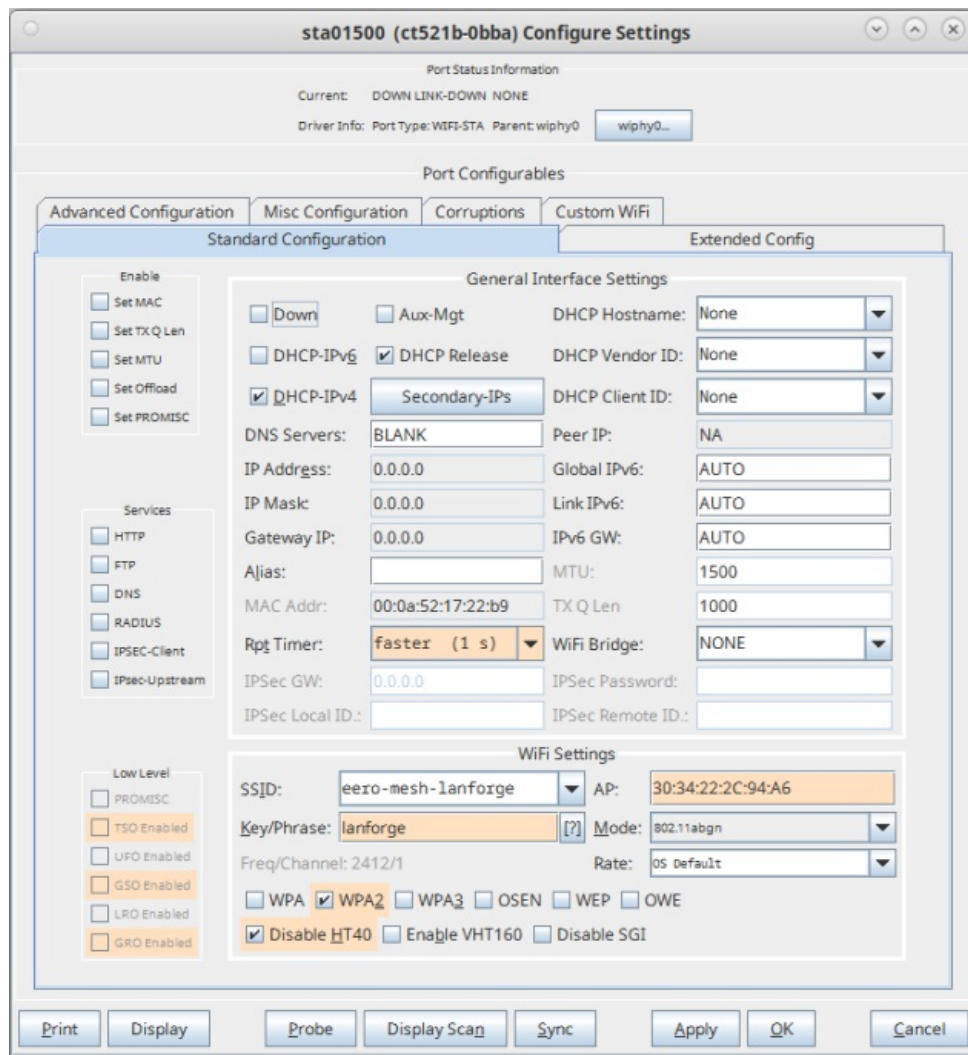
- Configure station for something easy to sniff (20Mhz a/b/g/n) by clicking the Disable HT40 button in the Standard Configuration tab. Then click Apply and OK to close the Configure Settings window for the station.

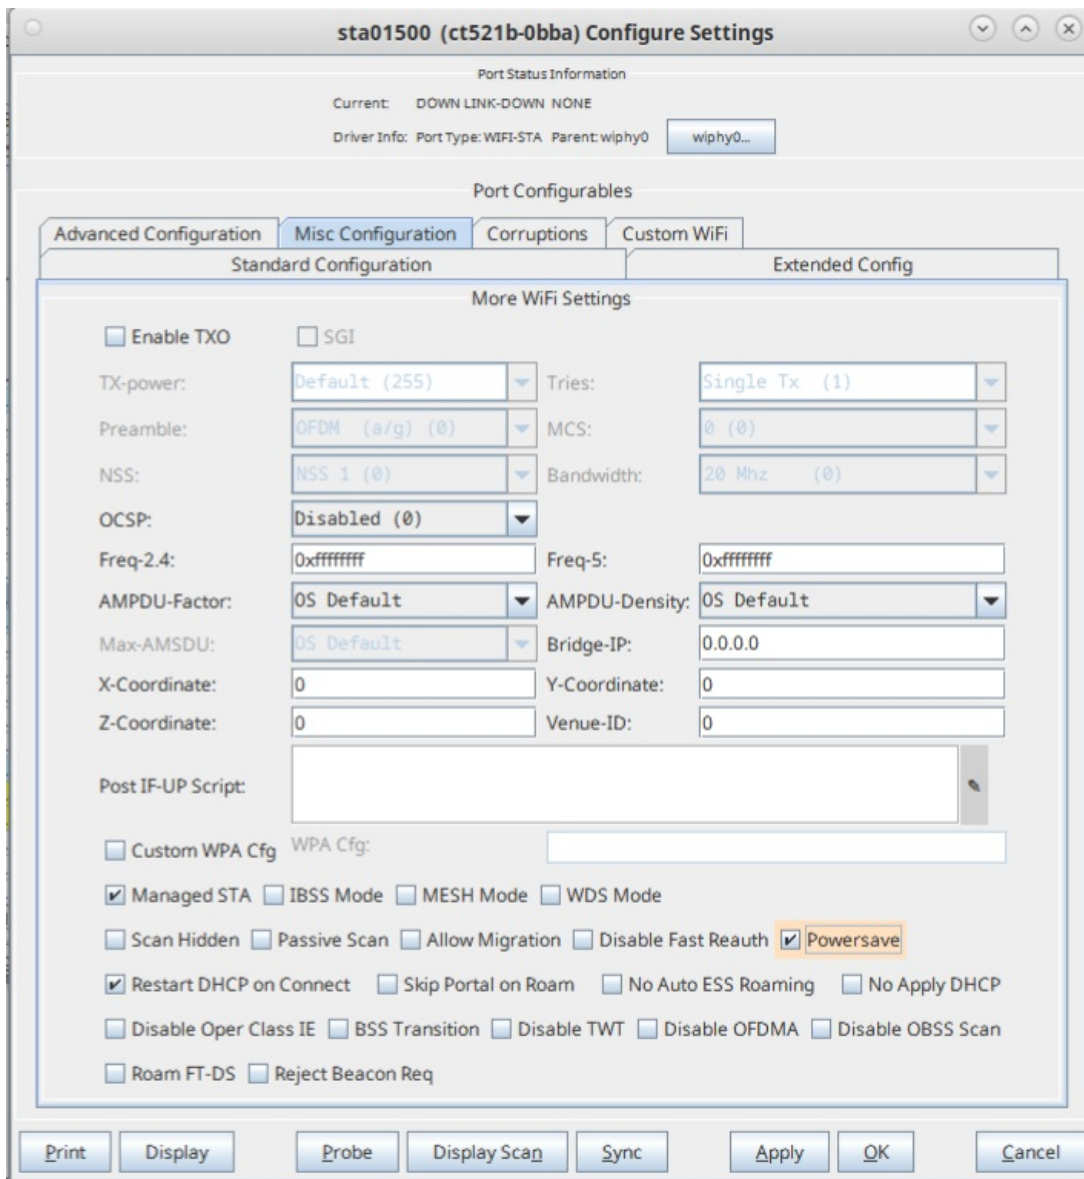
- Configure AP for bridge mode so that NAT is not an issue. Follow the following cookbook link to configure the AP in bridge mode: <http://www.candelatech.com/cookbook.php?vol=wifi&book=wifi+VAP+bridge>
- Double-click on the created station in the Port Mgr tab. Enable Powersave on LANforge station (in the Misc Configuration tab)

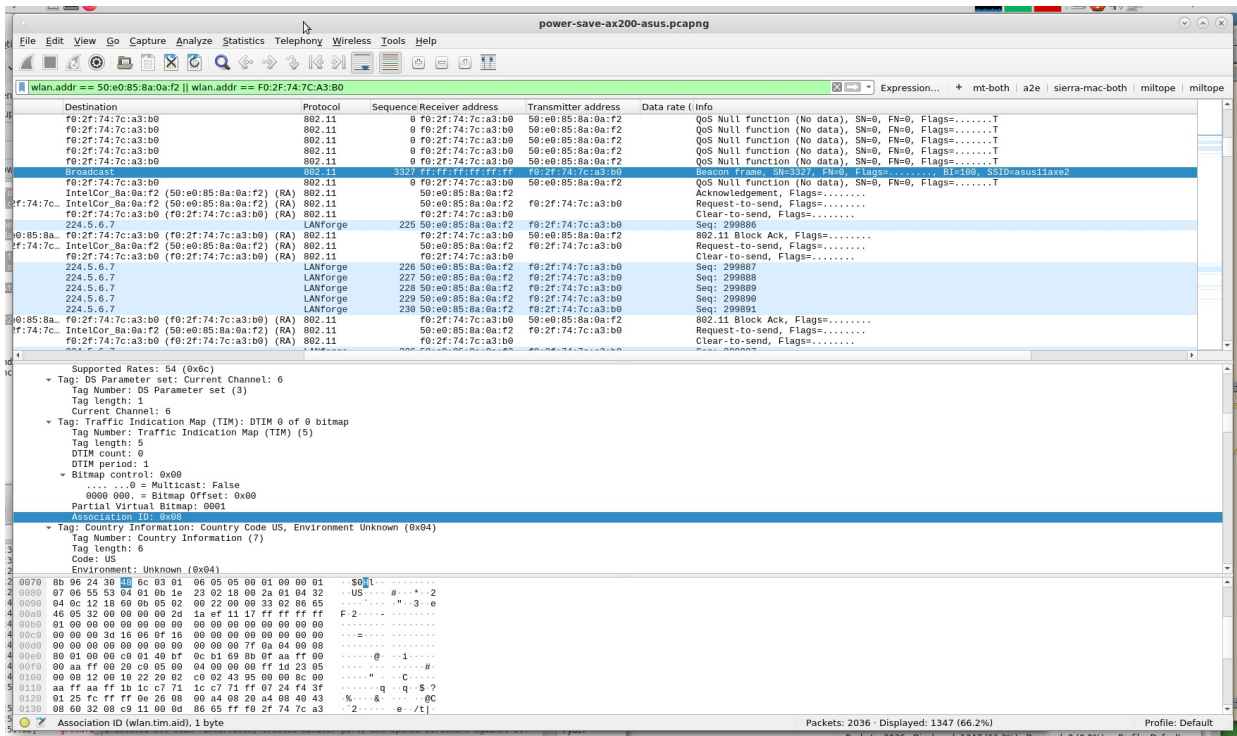
Starting with frame 227, a beacon frame, the AP indicates in the TIM IE that (unicast) data is waiting for the station with Association ID (AID) 0x8. This is the LANforge station in question, where it's AID is seen in the 'Probe' text dump in LANforge. This can also be seen by looking at the association frames, though this is not part of the capture. The TIM does not set the Multicast bit since this AP is converting multicast to unicast.

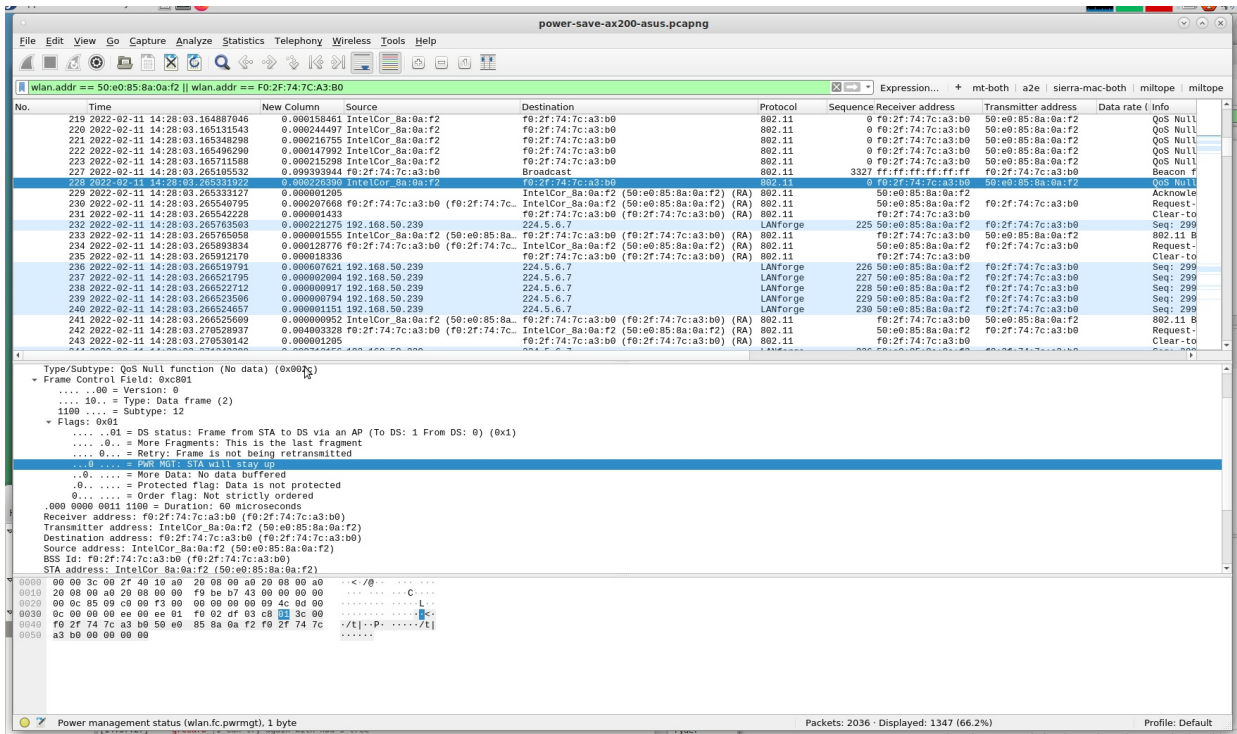
Frame 228 is from the station. It will always wake up to receive the beacon so that it can check the TIM element to see if it needs to stay awake and tell AP it needs to receive frames. Frame 228 is a few microseconds after the beacon, and STA tells the AP that it is waking up (because the AID was set in the TIM), and so AP can send traffic to it:
